TEMPERATURE DIFFERENCE DURING THERMOPICTURING
WERE OUTSIDE -19.7°C
INSIDE +20°C

Report Date 16.3.2010

Company Koulutuskeskus Salpaus
 Address Ståhlberginkatu 6, LAHTI
 Thermographer Matti Haara / Risto Rantasalo / Students

Customer Timo Kauppi
 Site Address Kimmelkatu 2, LAHTI
 Contact Person Timo Kauppi

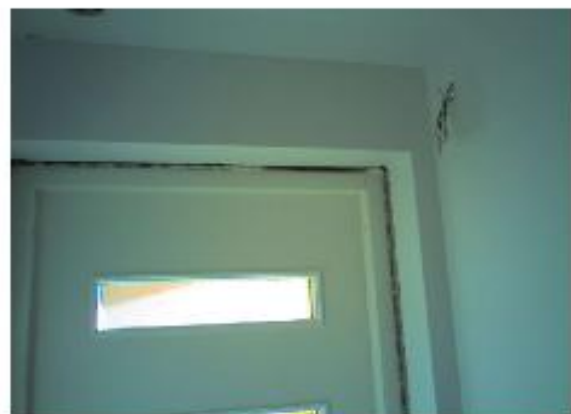
Point 1 Main entrance door right upper corner Piste 1 I kerros ulko-ovi ylänurkka	Point 1 Main entrance door Piste 1 I kerros Ulko-ovi
--	---

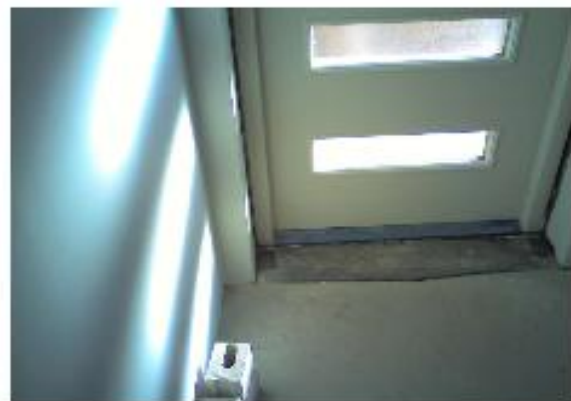
Camera Model	FLIR B360_ Western	Possible defect	Broken insulation strip
Image Date	24.2.2010 9:04:16		
Image Name	IR_0151.jpg		
Emissivity	0,84		
Reflected apparent temperature	20,0 °C		
Object Distance	1,0 m

Description	
Point1 1st floor main entrance left lower corner Piste1 Ulko-oven vasen alakulma	Point1 1st floor main entrance left lower corner Piste1 Ulko-oven vasen alakulma

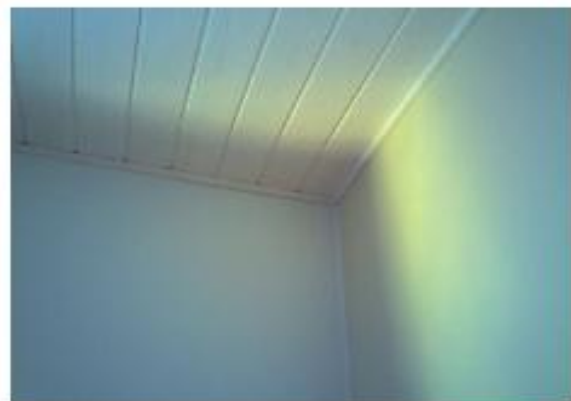
Point 2 1st floor The corner of ceiling at the living room Piste 2 Ensimmäinen kerros olohuoneen katon nurkkaus	Point 2 1st floor The corner of ceiling at the living room Piste 2 Ensimmäinen kerros olohuoneen katon nurkkaus
--	--

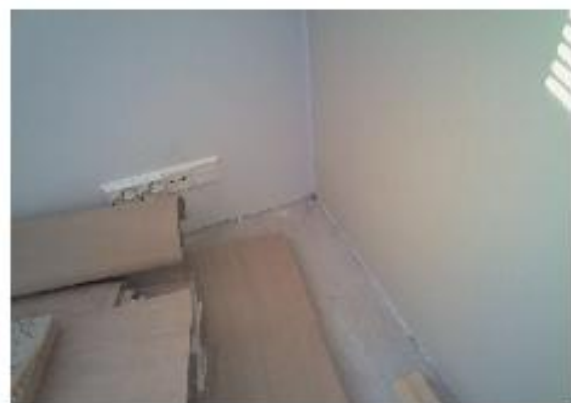
Description	
Point 2 1 st floor The corner of floor at the living room Piste 2 1 kerros olohuoneen lattian nurkkaus	Point 2 1 st floor The corner of floor at the living room Piste 2 1 kerros olohuoneen lattian nurkkaus

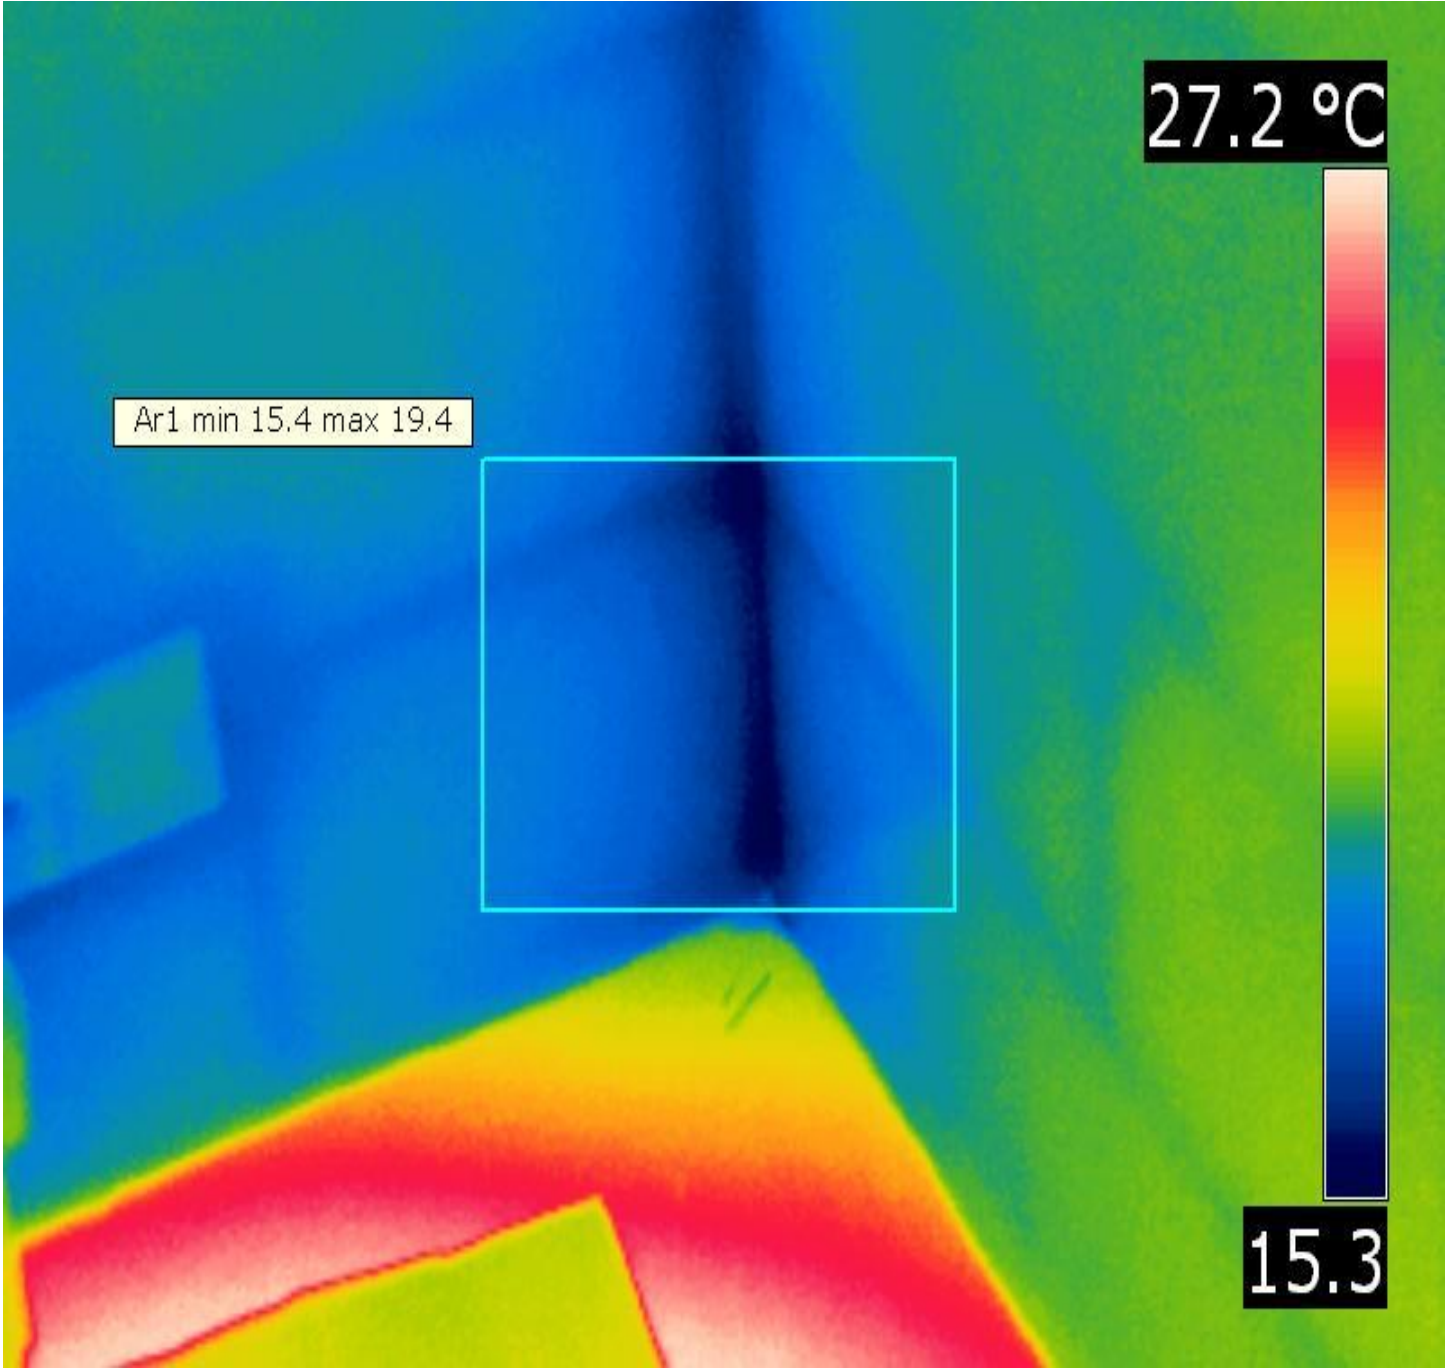
Camera Model	FLIR B360_ Western
Image Date	24.2.2010 8:48:49
Image Name	IR_0147.jpg
Emissivity	0,84
Reflected apparent temperature	20,0 °C
Object Distance	1,0 m

Description	
Point 3 1st floor storage room bottom line of the window Piste 3 I kerros varasto ikkunan alareuna	Point 3 1st floor storage room bottom line of the window Piste 3 I kerros varasro ikkuna

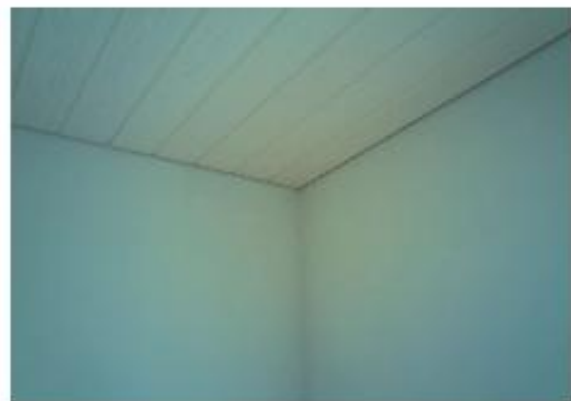
Description	
Point 1 2 nd floor bedroom the corner of the ceiling Piste 1 II kerros makuuhuone katon raja	Point 1 2 nd floor bedroom the corner of the ceiling Piste 1 II kerros makuuhuone katon raja

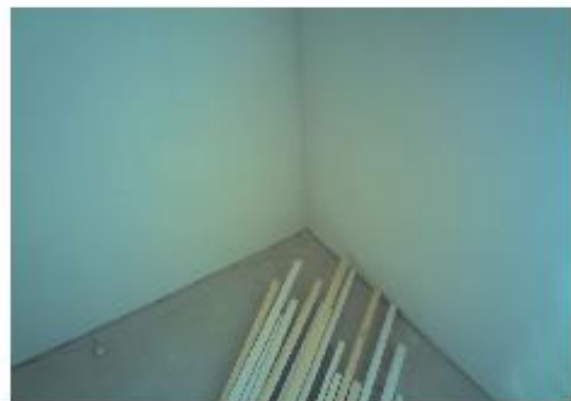
Description	
Point 1 2 nd floor bedroom corner of the floor Piste 1 II kerros makuuhuone lattia raja	Point 1 2 nd floor bedroom corner of the floor Piste 1 II kerros makuuhuone lattia raja

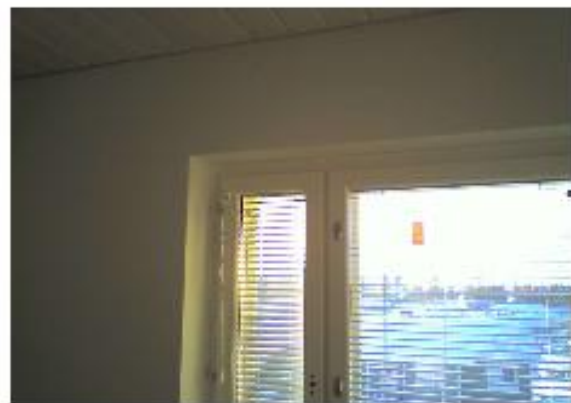
Description	
Point 3 2 nd bedroom window upper corner Piste 3 II kerros makuuhuone Ikkuna	Point 3 2 nd bedroom window upper corner Piste 3 II kerros makuuhuone Ikkuna

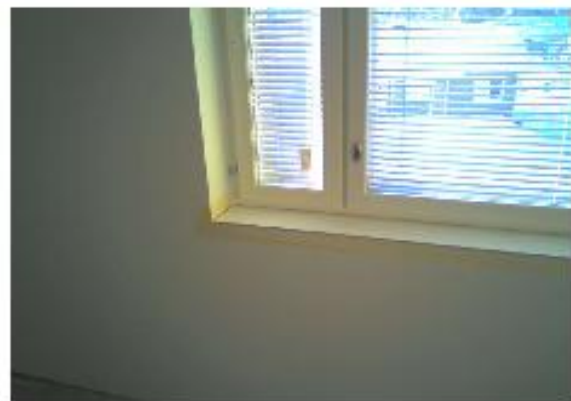
Point 3
 2 nd floor bedroom lower corner of the window
 Piste 3
 II kerros makuuhuoneen ikkunan alaosa

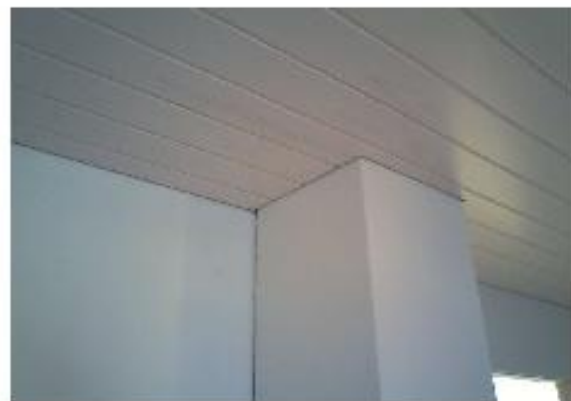
Description	
Point 4 2 nd floor chimney upper corner Piste 4 II kerros piipun yläosa	Point 4 2 nd floor chimney upper corner Piste 4 II kerros piipun yläosa

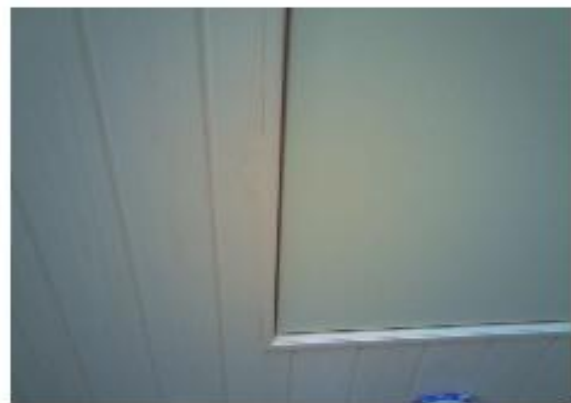
Point 5
 Access door to the attic space
 Piste 5
 II kerros kattoluukku
